Notes to OSET-NTP Trial 12 Performance Certificate for AES-38 Treatment System

1. AES (Advanced Enviro-septic) System Installed at OSET-NTP

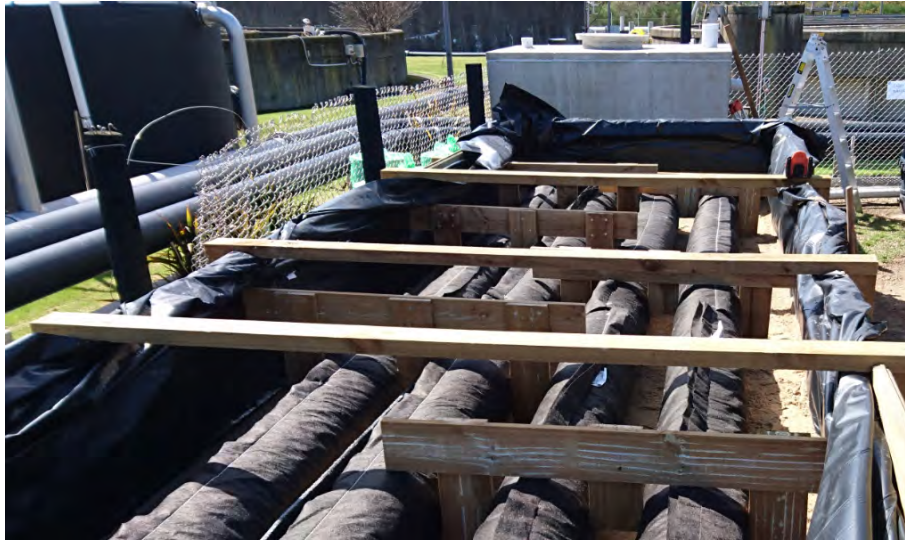
Photo 1. AES bed during construction with the septic tank in the background

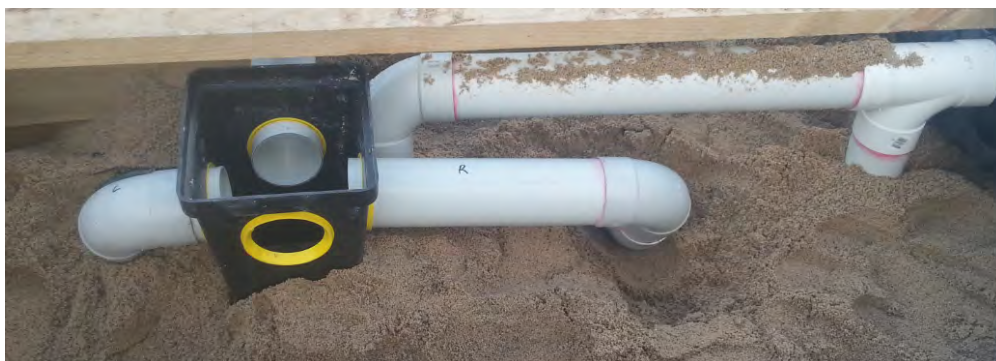
Photo 2. Distribution box during installation showing the two outlet ports at each side

The port on the far side of the box is used for the low vent. The hole with the yellow seal visible is the inlet port. The other pipework in the photo is the high vent manifold connecting rows 2 and 4.

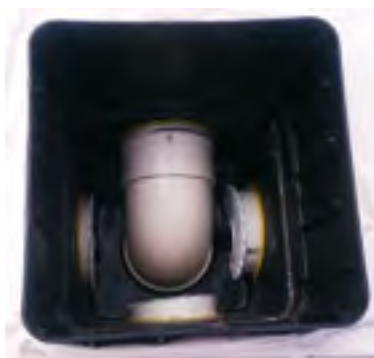
Photo 3. Distribution box in use. The inlet has an 88 degree bend so that effluent from the septic tank discharges below the liquid level in the distribution box. This forms a water trap and prevents air from upstream of the distribution box from accessing the venting airflow. The two outlet ports have flow equalisers which have an offset orifice. These can be rotated to change the level of the orifice to enable the effluent flow to be split evenly between the two outlet ports.

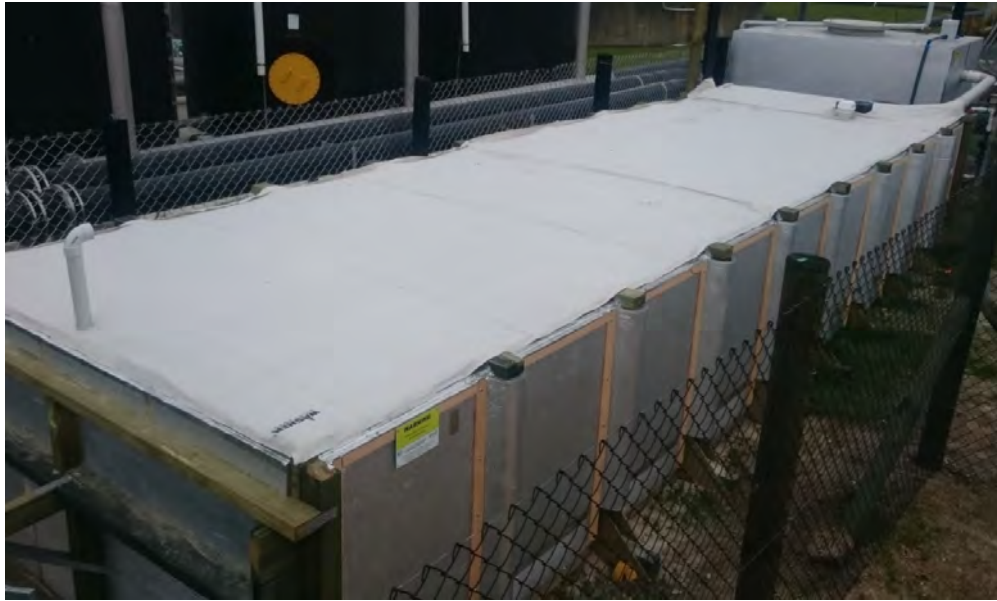
Photo 4. Completed installation. The sides of the AES bed and sides and top of the septic tank were insulated to lessen the extremes of temperature associated with being above ground. The top of the AES bed had 100mm – 150mm of sand on top of the impermeable liner, and canvas over the sand to prevent the sand from blowing away.

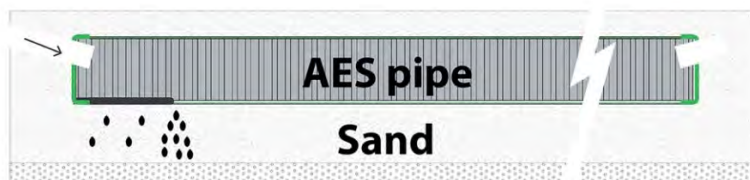
Figure 2. Biofilm build up in AES pipes

Stage 1: Horizontal buildup of Biofilm along the length of the pipe.
When Biofilm reaches the end of the row the row has 'started up'.

As overflow into and discharge – albeit in low volumes – through row 4 occurred, this is evidence that rows 1 and 3 had started up, as shown in stage 2 of Figure 2 below. It is assumed that overflow into row 2 also occurred. Biofilm growth in rows 1 and 3 reduces the permeability which results in the liquid level rising until flow through the raised connectors - 100mm PVC pipework - occurs.

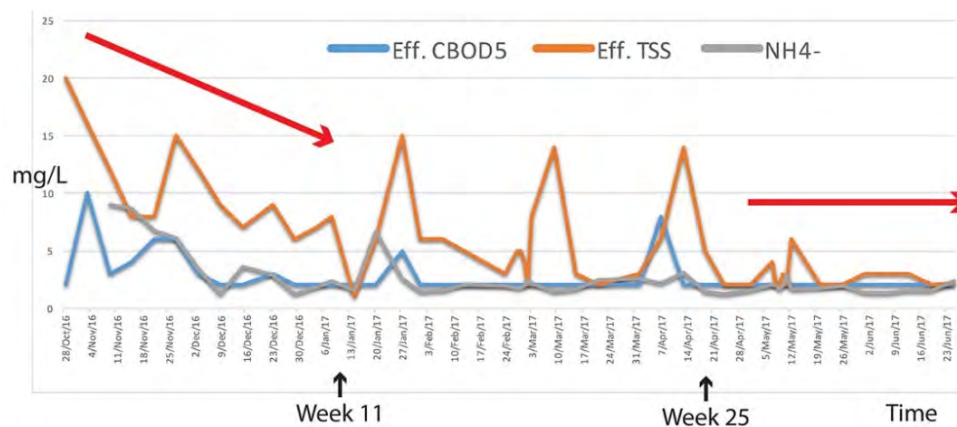
When the AES-38 results from weeks 1 – 35 of Trial 12 are plotted on a graph there are three phases. During phase one treatment quality improves while the biofilm establishes along the length of the row. In phase two treatment quality becomes more stable after the biofilm has developed along the length of the row, and the row has started up. Biofilm continues to establish up the sides of the pipes. After Week 25 the treatment quality is very stable suggesting a third phase - equilibrium - has been reached – the biofilm growth is limited only by the influent nutrients, and is sufficient to slow the movement/ maximise the treatment of all the influent.

Figure 3. Trends in AES-38 OSET-NTP Trial 12, Weeks 1 – 35

The erratic TSS values in the second phase may have been due to silt in the sand around rows 2 and 4, and silt in the row 4 underdrain being washed out as effluent first reached rows 2 and 4.

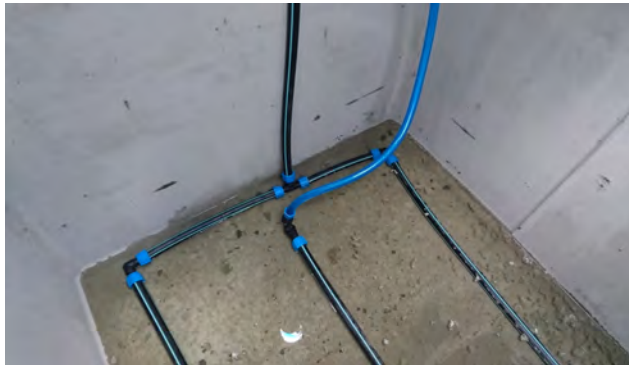
Photo 5. Pipe network inside the septic tank through which treated effluent can be recirculated

On the completion of Trial 12 the AES-38 system was reconfigured to enable recirculation of the treated effluent back through the anaerobic septic tank and AES bed, in order to enhance nitrogen reduction. The reconfigured system, an AES-38 R, ran for 11 weeks and achieved TN <10mg/L. The system is taking part in OSET-NTP Trial 13, 2017-18.
